# **Results of Field Monitoring Prototype Floorbeam Connection Retrofit Details on the Birmingham Bridge**

**Final Report**

**ATLSS Report No. 04-04**

**February 2004**

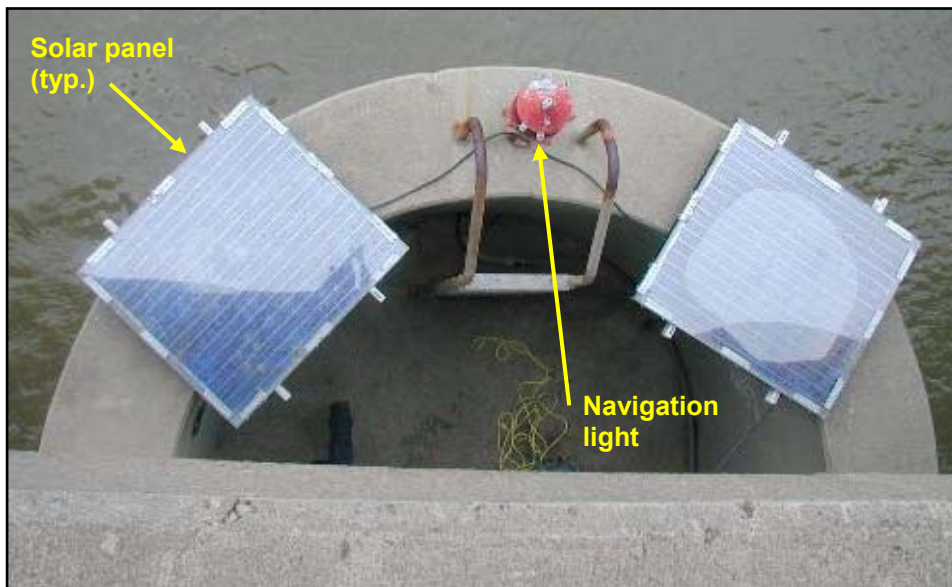
In order to ensure the batteries would remain charged, Penn DOT provided an electrical contractor who “tapped in” to the power supply line for the navigation lights installed on the pier (See Figure 12). Using a 120 VAC marine battery charger and a special charge controller, the batteries were recharged during the evening using the power from the navigation light system. The circuit had ample capacity to fully charge the batteries by morning so that they could operate the logger during the daylight hours. It should be noted that due to a problem with a circuit breaker that powered the navigation lights, power was not provided to the battery chargers about eight days after the remote monitoring program began. The breaker was subsequently reset and power restored with no further problems. Although the exact cause for the power outage is not known, it is believed that water entered an existing damaged navigation light fixture and tripped the breaker during a period of heavy wind-driven rain.

Figure 12 - Photograph of solar panels initially installed on north pier and navigation light

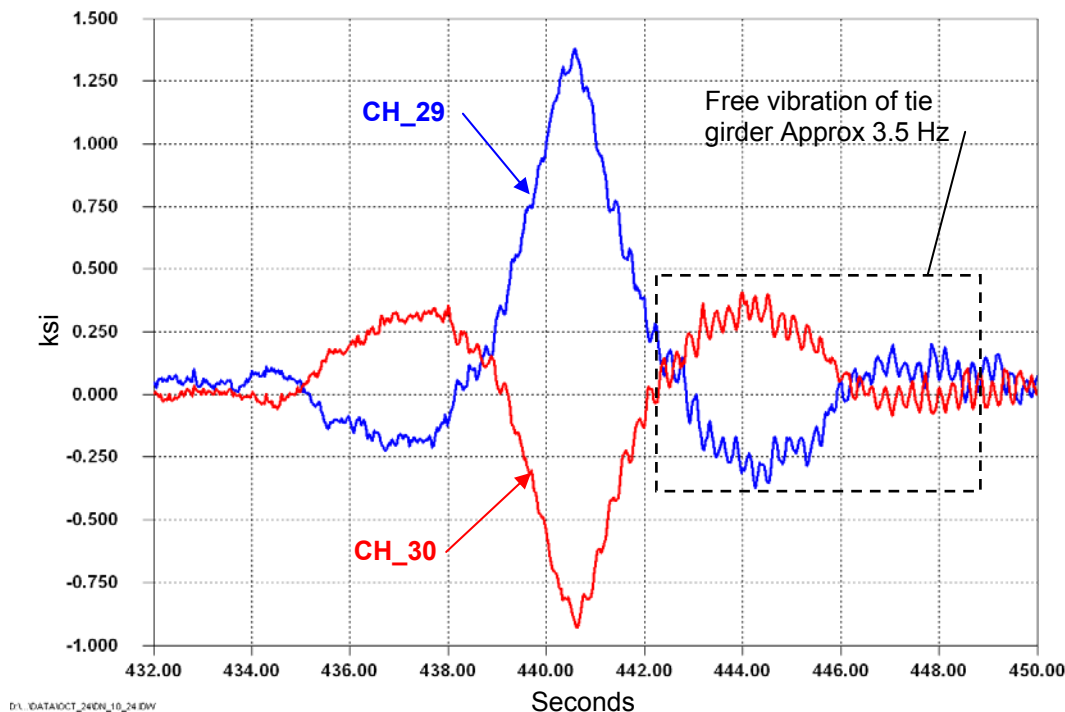
Figure 14 shows a typical response of the tie girder as a single vehicle crossed the bridge. As can be seen, CH\_29, located on the bottom of the tie girder is subject primarily to a tensile stress while CH\_30 is primarily in compression. This suggests that bending stresses with some stress reversal dominate the response of the tie as individual vehicles cross the bridge.

Figure 14 - Response of the down stream tie girder as a random vehicle crossed the bridge

Although the tie girder is typically thought of as a pure tension member, bending stresses dominated the response as individual trucks crossed the bridge. However, axial tension was included in the measurements, though it was a much smaller component of the total stress cycle.

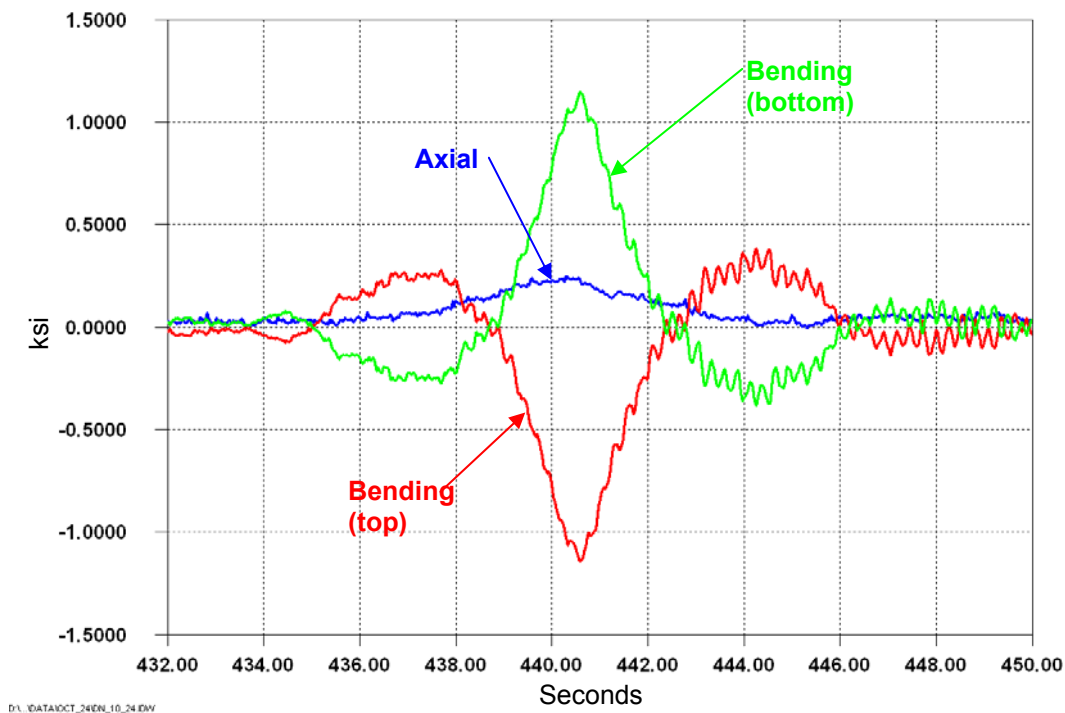
This is readily observed in Figure 15 in which the axial and bending stress components are separated. The data presented are for the same event presented in Figure 14. As can be seen, the bending component far exceeds the axial tension component.

Both Figures 14 and 15 indicate that positive and negative moments are produced (noted by the observed stress reversal) as the vehicle passes. The measured response is comparable to that of a continuous span girder. The gages are located 3'-9½" north of the center hanger and other hangers are spaced at 31.0 feet. Under live load, the maximum stresses in a continuous beam with rigid supports at the same location would be expected to produce a negative moment (*i.e., the hanger can be thought of as an interior support*). The measured stresses indicate a large positive moment is produced as the vehicle passes, which is consistent with a flexible "support" (*i.e., the hanger near the gages*) which allows vertical deflection under load. As the support "settles", the applied load produces a positive moment. Similar response has been observed on other tied arch members on bridges instrumented by the researchers. As the vehicle moves further from midspan, the bending local effects diminish, as would be expected in a continuous beam.

Figure 15 - Axial and bending components of the down stream tie girder developed from data presented in Figure 14.

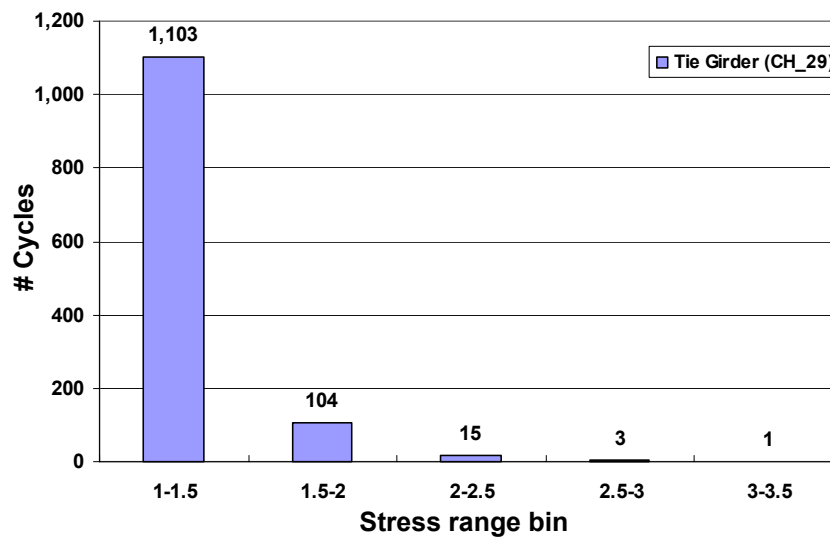
The stress-range histogram ignores all cycles less than 1.0 ksi. Table 4 lists the effective stress range  $S_{\text{reff}}$ , maximum stress range  $S_{\text{rmax}}$ , and number of cycles generated per day. It was conservatively assumed that the lowest fatigue category on the flanges of the tie girder is category D. The constant amplitude fatigue limit (CAFL) for category D is 7.0 ksi. It can be seen from the histogram and Table 4 that the maximum measured stress range is half the CAFL and only one primary stress range cycle is produced per vehicle passage. Based on the field monitoring, no load induced fatigue problems would be expected in the tie girder.

Figure 16 - Stress-range histogram for channel CH\_29 located on the bottom flange of the downstream tie girder near midspan

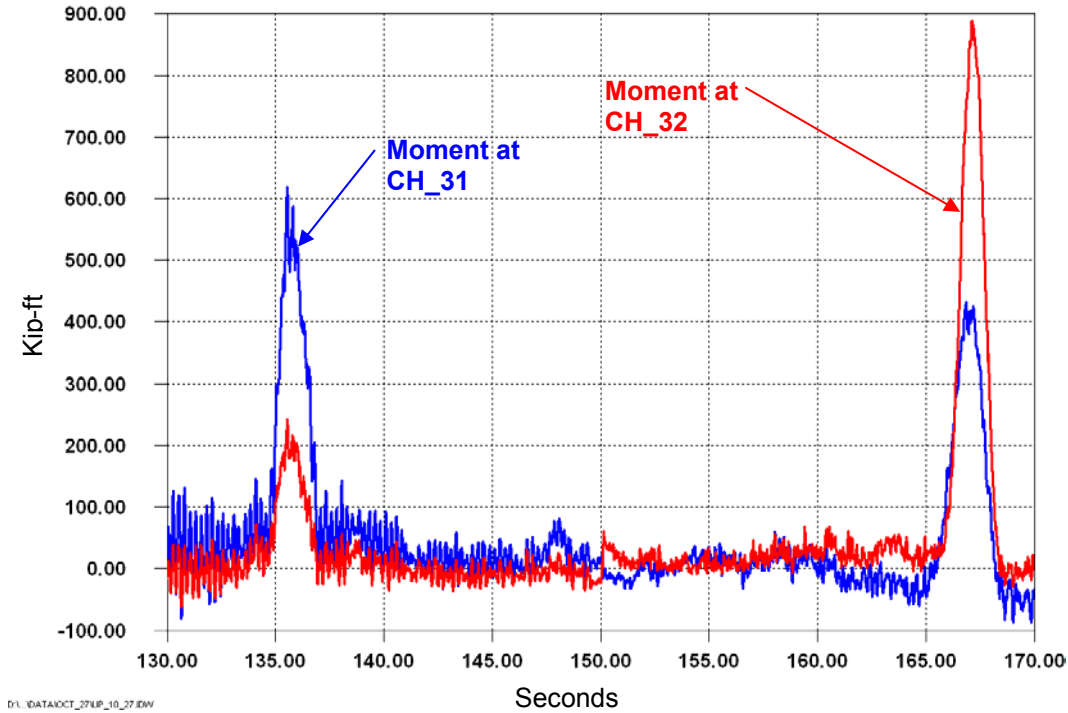
Figure 18 is plot of moments calculated from the field measured stresses as two different trucks crossed the bridge. Recall that channels CH\_31 and CH\_32 were located under the upstream or northbound lanes. The data presented in Figure 18 were collected as two separate trucks crossed the bridge on the upstream side, most likely in the inside and shoulder lane respectively. Note that regardless of truck position, positive moments (i.e., tension in the bottom flange) are produced. If any significant negative moment was being generated, the moments near the tie girder would be expected to be very small or even negative.

Figure 18 - Measured moments in floorbeam at CH\_31 (*located near midspan*) and channel CH\_32 (*located near tie girder*).

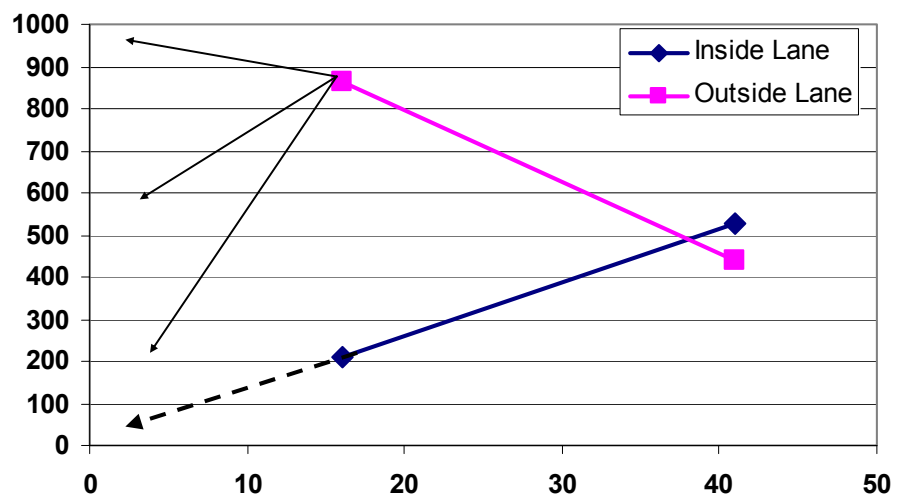
Figure 19 is an estimated moment diagram using the data in Figure 18 for each of the events or “trucks”. As can be seen, when the truck is in the inside lane (*first truck*), almost no moment is projected at the tie girder. However, when the truck is in the outer or shoulder lane (*second truck*), there is significant positive moment measured near the tie. It would seem unlikely that the moment reduces to zero that sharply, but rather some level of positive moment (*as illustrated by the possible moment diagrams in the figure*) is produced.

If a positive moment was produced, it would be consistent with the results of measurements on the tie girder and on the connection angles. As noted, positive moments are produced in the tie girder due to the flexibility of the hanger ropes and arch rib. A “settling” of the tie girder, which occur when the load is directly over the floorbeam, would produce a positive movement at the end of the girder (*obviously this is only true if some restraint is present*). As will be discussed, the response of gages on the horizontal portion of the cut were subjected to compressive stresses in some loading events. This observation would also be consistent with the above.

Figure 19 – Comparison of moments produced by trucks in different lanes

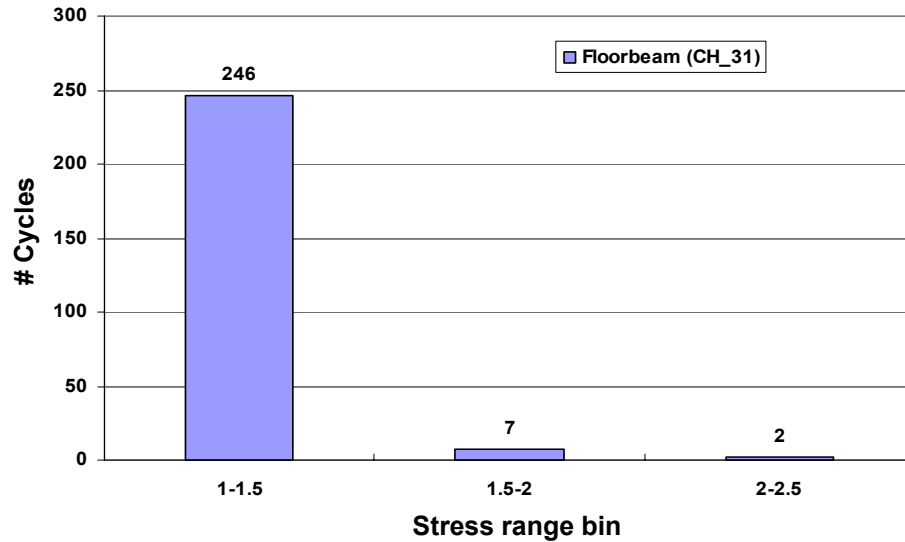
Overall, the stress ranges measured in the floorbeam by individual trucks were small. As shown in Figure 17, individual trucks produced a single primary stress cycle per passage. This is typical of large transverse members. A stress-range histogram was only developed for channel CH\_31, located near midspan on the bottom flange. The histogram for CH\_31 is presented in Figure 20, in which cycles less than 1.0 ksi were ignored. Based on the results of the long-term monitoring, the main section of the floorbeam (i.e., other than at the connection to the tie girder) would be expected to have an infinite fatigue life.

Figure 20 - Stress-range histogram for channel CH\_31 located on the bottom flange near the midspan of floorbeam 19

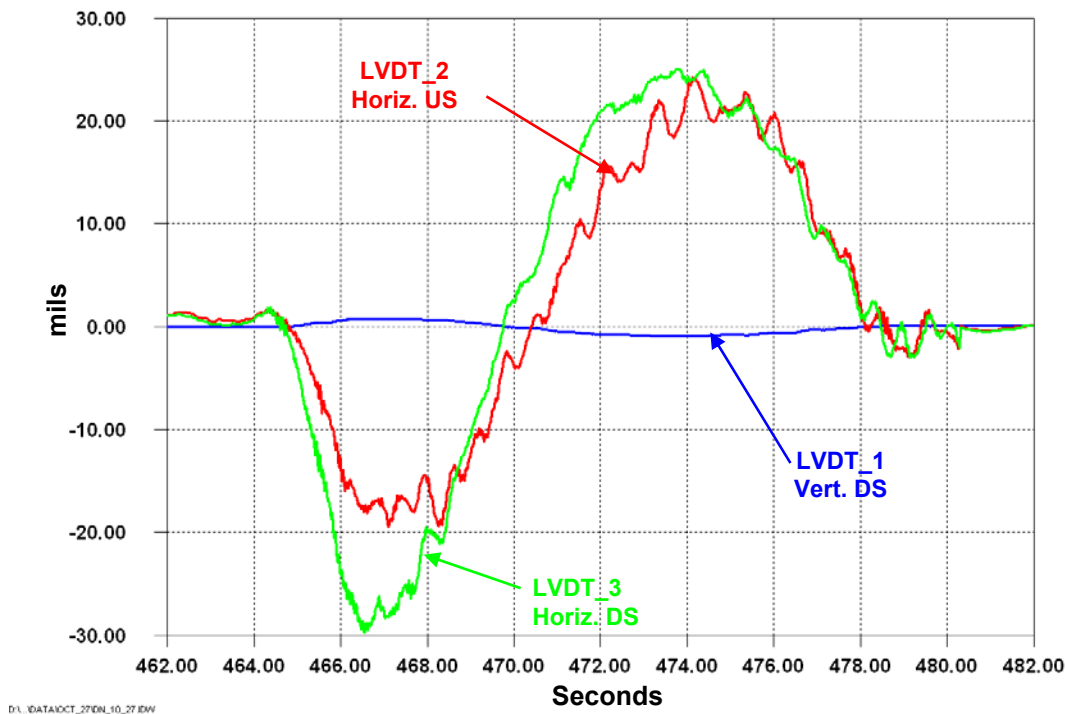
Figure 23 - Response of all LVDT's as a random truck crossed in the downstream lanes

Figure 23 compares the response of these LVDT's as a random truck crossed in the southbound lanes (i.e., downstream side). The displacement data are in “mils” or 0.001 inch units. The shape of the response curves for the horizontal LVDT\_2 and LVDT\_3 are similar to that observed from the strain gages and is consistent with the bending behavior discussed above. Slightly larger deformation range can be seen at the downstream end of FBL19 since the truck was in the downstream side. In fact, the response signatures of an LVDT and the corresponding strain gage are essentially identical. This is seen in Figure 24 that compares the response of LVDT\_3 and the response of CH\_16. With the exception of the difference in units (i.e., ksi vs. mils) the response is identical. It is also important to note that the entire cycle lasts about 14 seconds indicating the response is global and not produced from local wheel loads. This was also discussed in the review of the strain gage data.

LVDT\_1, which measured the relative deflection between the flange and the web, consistently measured very small movement of about  $\pm 1$  mil, as shown in Figure 23. This further confirms that the vertical stresses measured at the web-to-flange weld were not produced by flange rotation. Rather the measured horizontal movements, which were much greater, produced the observed stresses in the web. It is this displacement and resulting stress range cycles that caused the observed cracking in the as-built configuration.

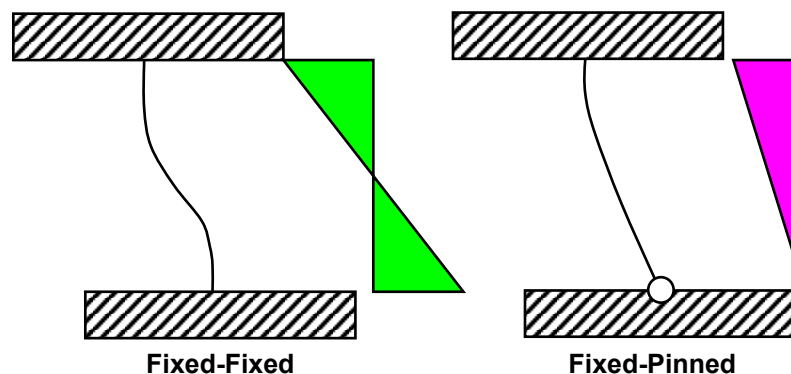
Figure 26 - Comparison of moment diagrams of fixed-fixed beam and fixed-pinned beams to illustrate the effect of softening the web as a result of the prototype retrofit

A simplified way to visualize this behavior is to contrast the moment diagram observed in a fixed-fixed beam and a fixed-pinned beam in which one end is held stationary and the other is displaced a certain distance. This is illustrated in Figure 26. The web of the floorbeam is represented by the beam. The upper restraint simulates the top flange, which is rigidly welded to the web and is displaced longitudinally. The top flange does not rotate since it is restrained by the stringer and the nearby stiffener. (*The small flange rotation was also confirmed by the measurements.*) The lower connection, which is illustrate as either fixed or pinned simulates the restraint provided by the lower portion of the web. According to the measurements, a very small amount of restraint is being provided by the web. In reality, the true behavior is somewhere between the two extremes shown in Figure 23. Based on the data, it is closer to the 'Pin' ended idealization. As a result, the demands on the web-to-flange weld are greatly reduced.

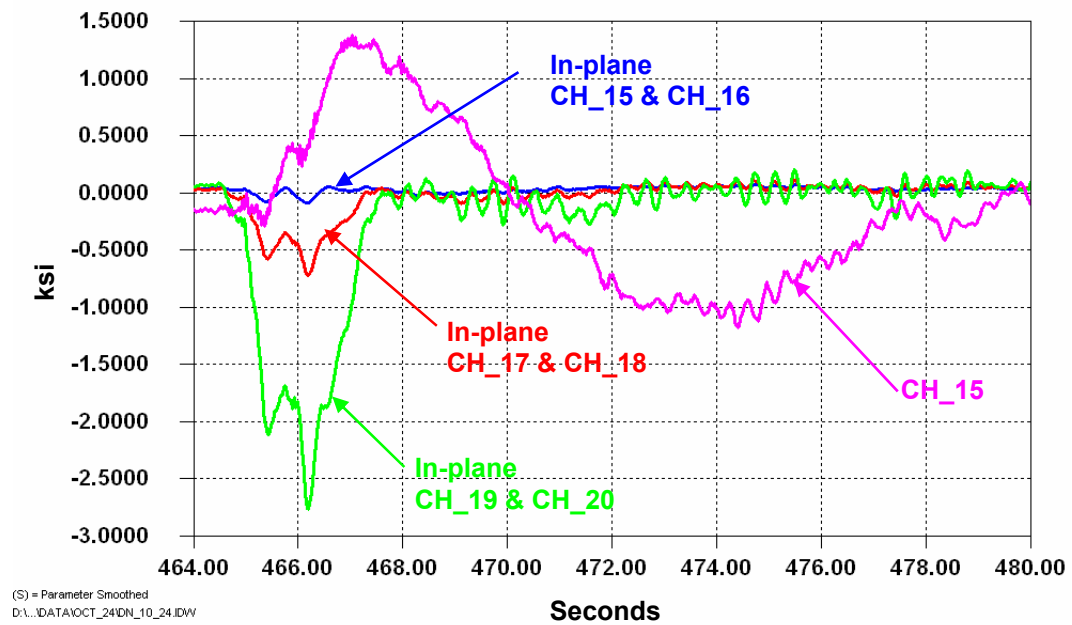
Figure 27 - Comparison of in-plane stresses along length of vertical cutout at downstream connection of floorbeam 19.

Review of Figure 25 indicates that in the region of channels CH\_19 & CH\_20 located near the bottom of the vertical cut, the out-of-plane stress component is very small. However, a comparison of the in-plane stress components reveals that in-plane stresses are greatest near the bottom of the cutout. This response is illustrated in Figure 27 which compares the in-plane or vertical stress component at each location along the vertical cutout. The increase in the vertical stress component toward the bottom of the cutout is expected. It can be seen that it is due to the vertical reaction of the stringer by comparing the length of time of the in-plane response with the total stress-range cycle, as shown in Figure 27. Notice that the length of time required for the in-plane stress-range cycle to occur is only about 3.2 seconds while the out-of-plane component, as illustrated with CH\_15 takes nearly 15 seconds. The reaction is maximized only when the load is in the immediate region above a given stringer, which only lasts for a relatively short period. For the data presented in Figure 27, the truck was headed south towards Carson Street. This is why the in-plane stress is maximized early in the stress-time history curve. A similar but reflected response is observed for trucks heading northbound.

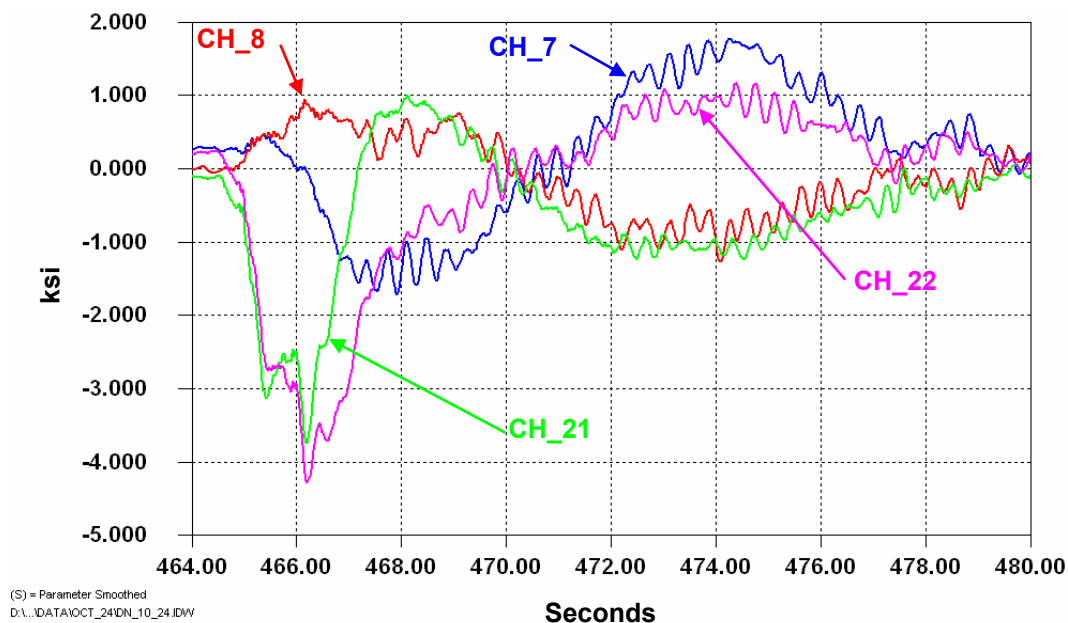
Figure 29 - Comparison of response at channels CH\_7 & CH\_8 located on the upstream connection and CH\_21 and CH\_22 located on the downstream connection as a random truck passed on the downstream side of the bridge

Figure 29 presents the response at channels CH\_7 & CH\_8 located at the upstream cutout and CH\_21 & CH\_22 located at the downstream cutout. These data were collected as a truck crossed on the downstream side of the bridge most likely in the outside lane. There is a markedly different behavior in the upstream and downstream connections. The stress-range cycle at the upstream side (CH\_7 & CH\_8) is primarily the result of longitudinal bending as evident by the response primarily from time  $t = 470$  seconds to time  $t = 478$  seconds. Channels CH\_21 and CH\_22 are also dominated by a similar response during that portion of the time history plot. However, contrast the response of upstream and downstream gages at the beginning portion of the cycle. Note the sharp negative stresses that are produced as the truck crosses floorbeam 19 while the response at CH\_7 & CH\_8 is relatively smooth. This suggests that the truck was in the downstream shoulder lane and directly loaded the floorbeam as it passed overhead. However, the response at the upstream side is only affected by the global response of the bridge as indicated by the strain gage data.

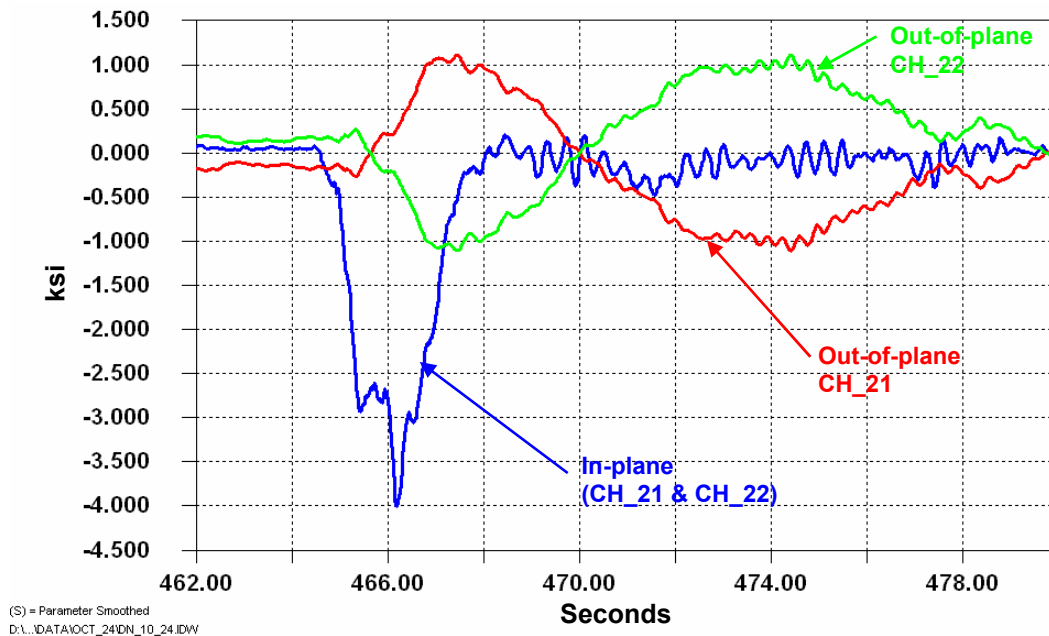
Figure 30 - In-plane and out-of-plane response at channels CH\_21 and CH\_22 as truck passed on the downstream side of the bridge

It is interesting to note that the primary response at downstream connection is compression confirming the development of a positive moment at the end connection when the vehicle is adjacent to it. Figure 30 presents the in-plane and out-of-plane response of the downstream gages for the same event shown in Figure 29. As can be seen, the compressive in-plane response dominates the cycle and occurs when the vehicle crosses the floorbeam while the out-of-plane bending is consistent with the global response due to longitudinal displacement. Similar behavior was observed at channels CH\_7 & CH\_8 as trucks crossed on the upstream side of the bridge.

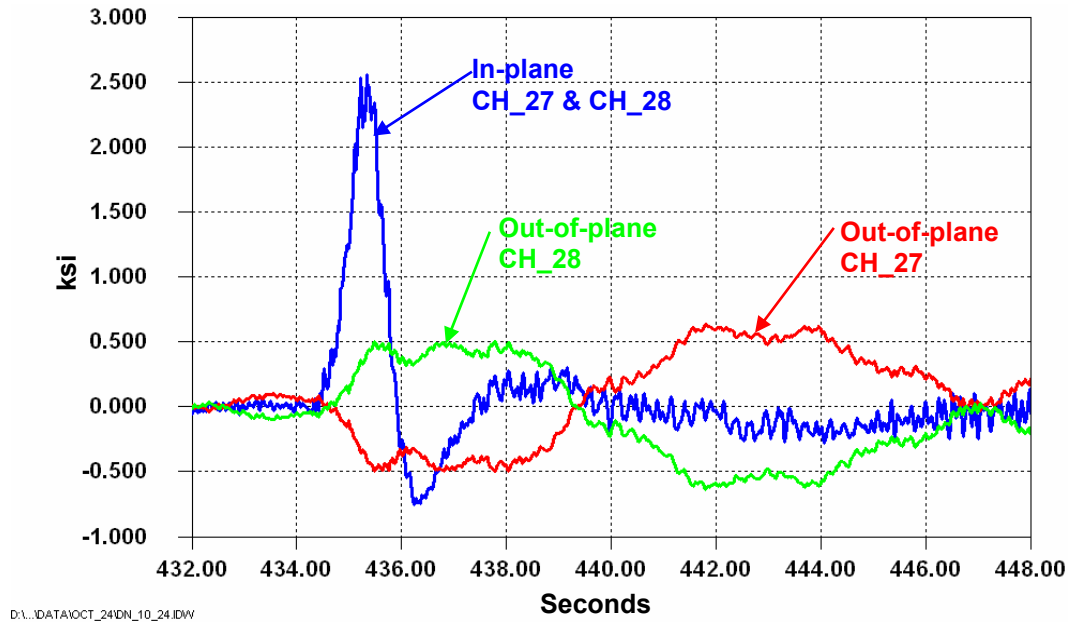
Figure 32 - In-plane and out-of-plane response at channels CH\_27 and CH\_28 installed on connection angles as truck passed on the downstream side of the bridge

As shown in Figure 32, in-plane tensile stresses are produced as the truck passes directly over floorbeam 19. This indicates that the web of the floorbeam is “pulling” on the connection angles at this location. This is due to the restraint provided by the connection, as it is not a true “pin” connection as assumed in design. However, considering the magnitude of the tensile component, the end fixity seems low. (*This was also suggested by the data from gages installed on the floorbeam flanges.*) The data also show that as the truck approaches and then crosses, smaller bending stresses are produced. This portion of the response is produced by the global response of the tied arch and not local stresses, as previously discussed. The same response was observed at the upstream connection.

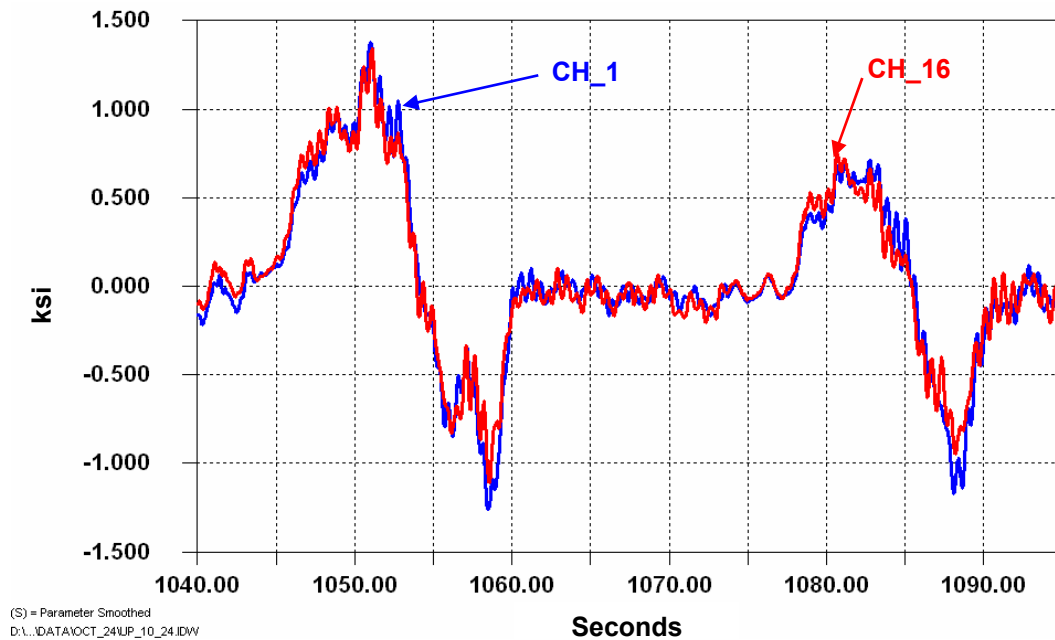
Figure 34 - comparison of response of upstream and downstream connections

Figure 34 presents the response of channels CH\_1 and CH\_16, located on the south face of the upstream and downstream connections respectively. Recall these gages were positioned vertically and immediately adjacent to the web-to-flange weld of the floorbeam. Figure 34 presents the response as two separate trucks crossed the bridge. As can be seen, the response is essentially the same for both the upstream and downstream gages although the trucks passed in the upstream lanes. If the measured stresses were the result of local effects, significant stresses would not be expected at the downstream connection as trucks passed in the upstream lanes. This further confirms that the observed cracks were driven by the global response of the bridge and not by local effects.

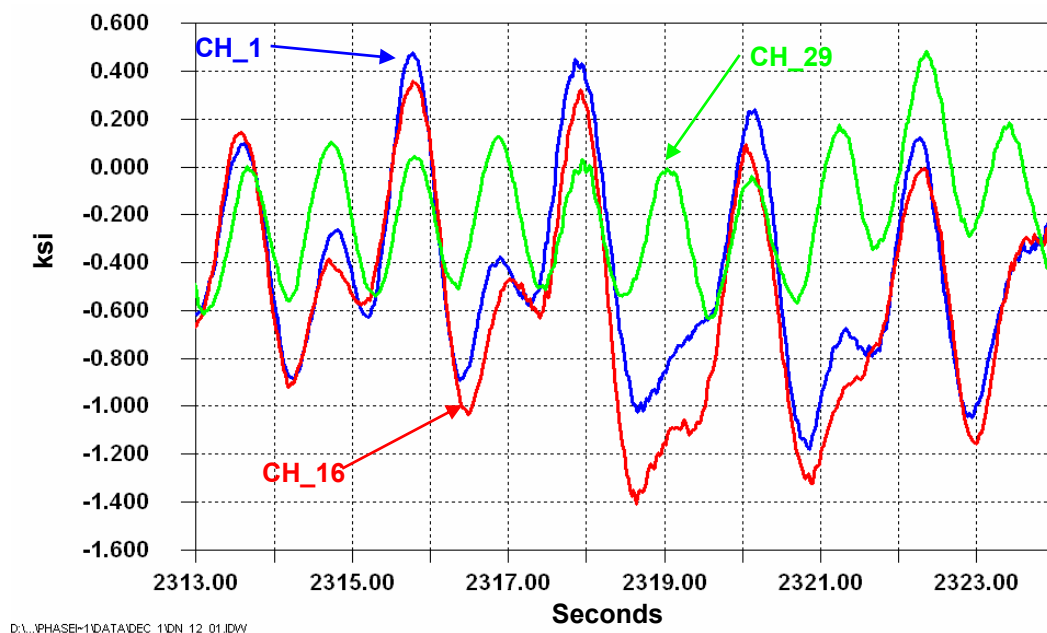
Figure 35 - Response of selected gages during the passage of a cold front on November 24<sup>th</sup>, 2003

Figure 35 presents a small portion of the measured response of channel CH\_29 on the bottom flange of the downstream tie girder. In addition, CH\_1 and CH\_16 located on the south face of the floorbeam web adjacent to the web-to-flange weld are also plotted. As can be seen, the response of the tie girder (CH\_29) is very different than observed as trucks cross the bridge, as is the response at channels CH\_1 and CH\_16. Several minutes of data were recorded during this event (Compare with Figure 12).

Although the above discussion is not intended to be used for any specific analysis, it does illustrate that winds in the 30 to 40 mph range have produced measurable stress-range cycles and possibly contributed to the fatigue damage observed.

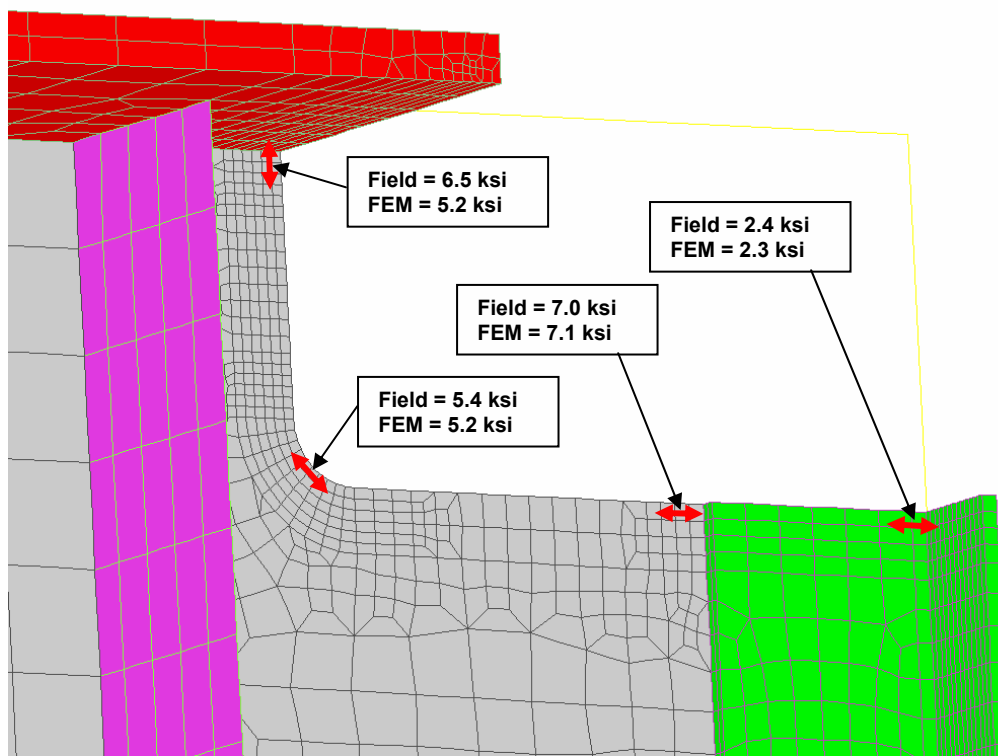
Figure 38 - Comparison of results from field measurements and FEM for prototype floorbeam connection retrofit on the Birmingham Bridge

Field measured and calculated (FE) data were compared at several critical locations. The results of this comparison are shown in Figure 38. The data are for a single event in which a very heavy truck crossed in the downstream lanes. This was the largest single event recorded during the remote monitoring program. Note that the results represent a complete stress-range cycle including stress reversals. *(For example, if the full cycle was -1.3 ksi to 4.2 ksi peak-to-peak, 5.5 ksi is reported in Figure 38.)* This vehicle produced a peak longitudinal relative displacement range of 100 mils and 121 mils at the upstream and downstream connections, respectively. As can be seen, the field and FE model data are in very good agreement, especially considering the complexity of the detail and the behavior.

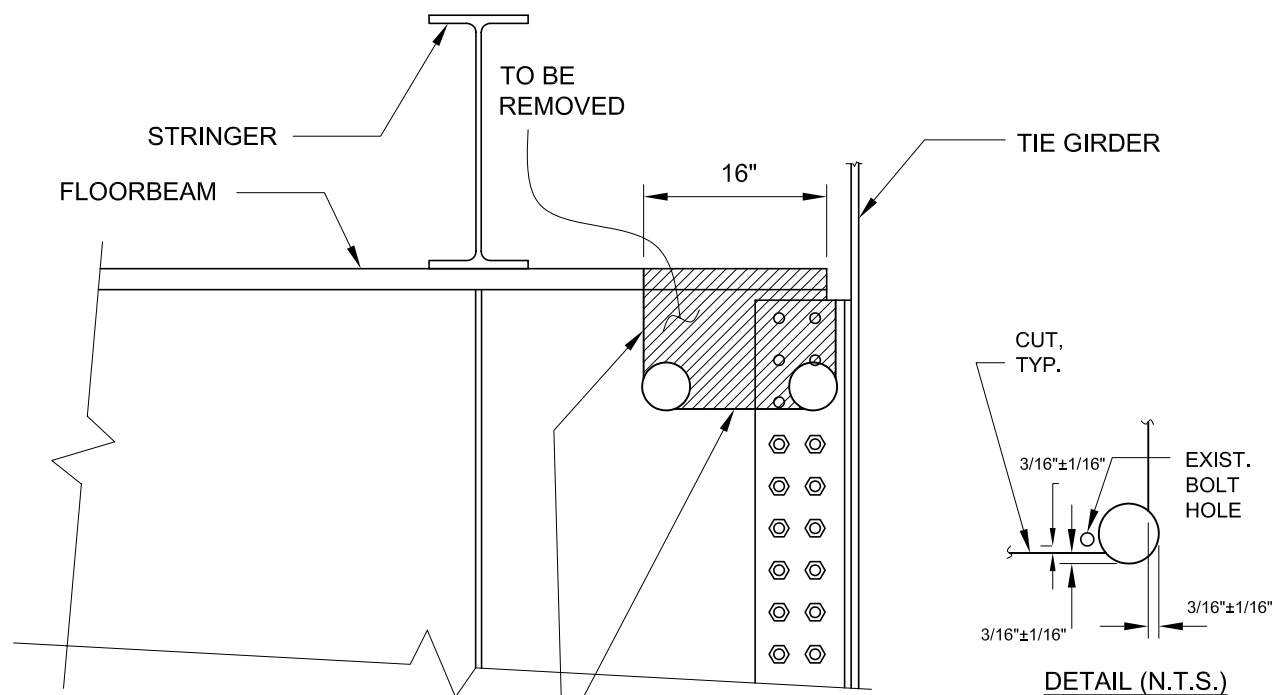
**FIGURE A3**

**STEPS 3 & 4**  
**CUT OUT ANGLES, WEB & FLANGE**

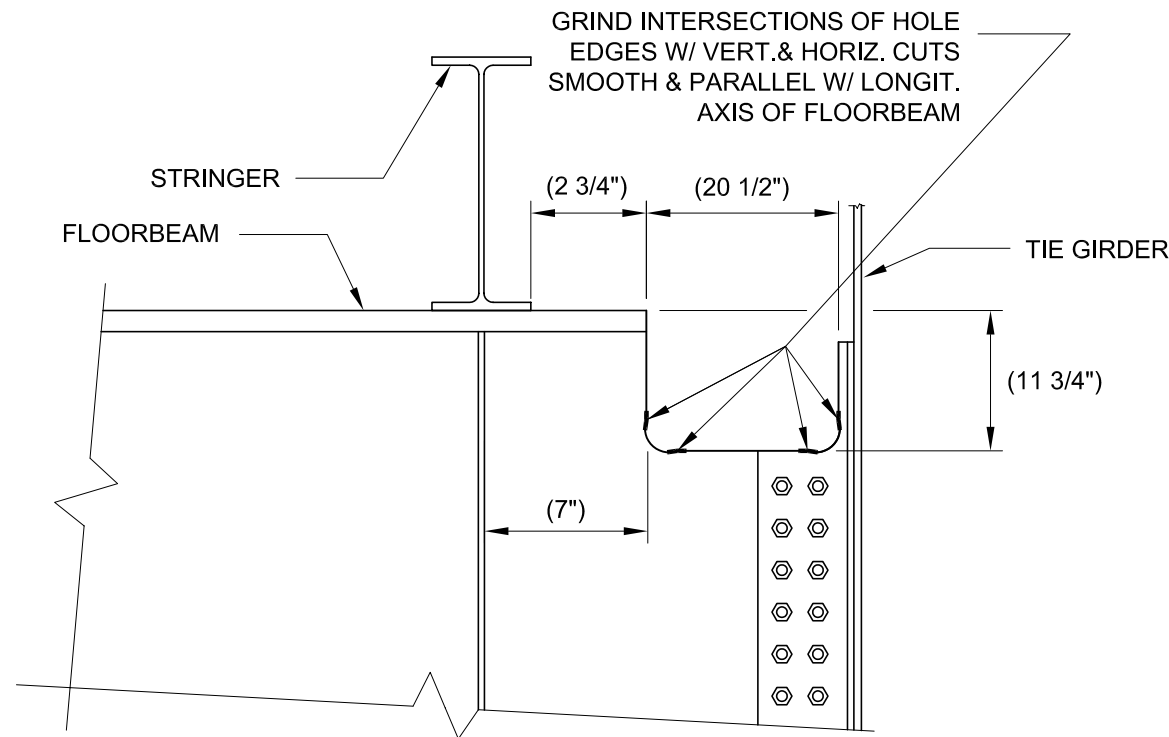
**FIGURE A4**

**STEP 5**  
**PREP CUT EDGES**
